INSPECTION REPORT

For the Property at:
612 SPRING ROAD
ANY TOWN, IL 00000

Prepared for: SAMPLE RESIDENTIAL
Inspection Date: Thursday, May 19, 2016
Prepared by: Bob Casey

RE: Report No. 1181, v.2
612 Spring road
Any Town, IL
00000

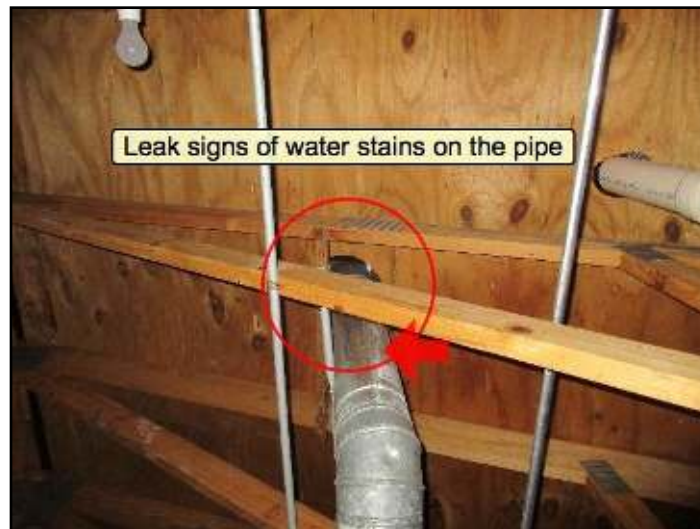
7. Leak

2. Condition: • [Leak](#)

The flue stack for the furnace and the water heater is leaking and needs to be repaired to prevent leaking

Implication(s): Chance of water damage to contents, finishes and/or structure

Task: Repair or replace Improve

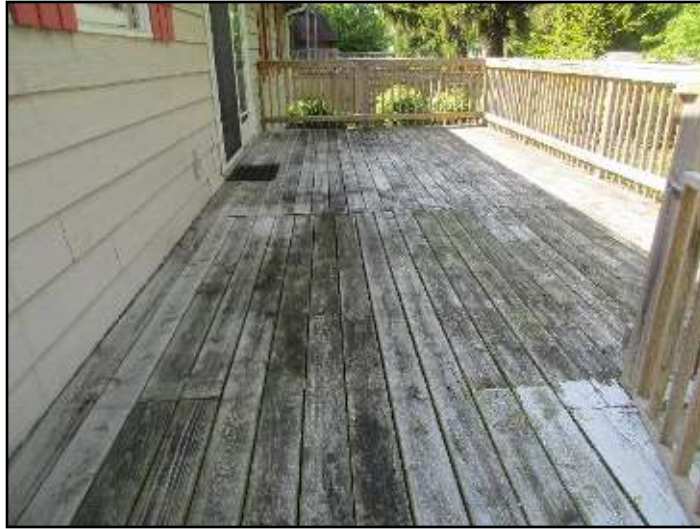
29. *Paint or stain needed*

4. Condition: • [Paint or stain needed](#)

The exterior deck on the home needs to be painted or stained to maintained the wood

Implication(s): Shortened life expectancy of material | Cosmetic defects

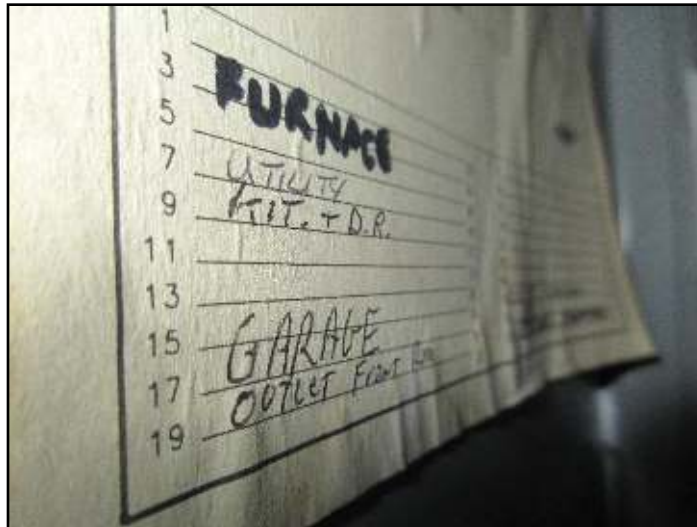
46. The accuracy of the circuit index (labels)...

• The accuracy of the circuit index (labels) was not verified.

Not all the breakers are labeled

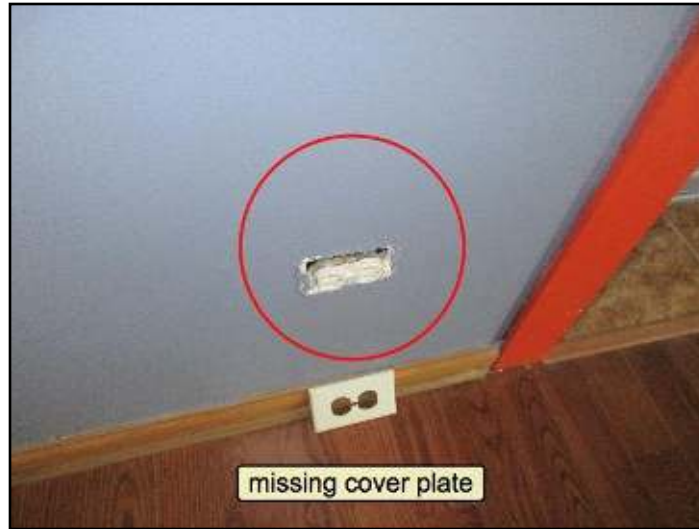
47. Damaged

7. Condition: • [Damaged](#)

Task: Replace

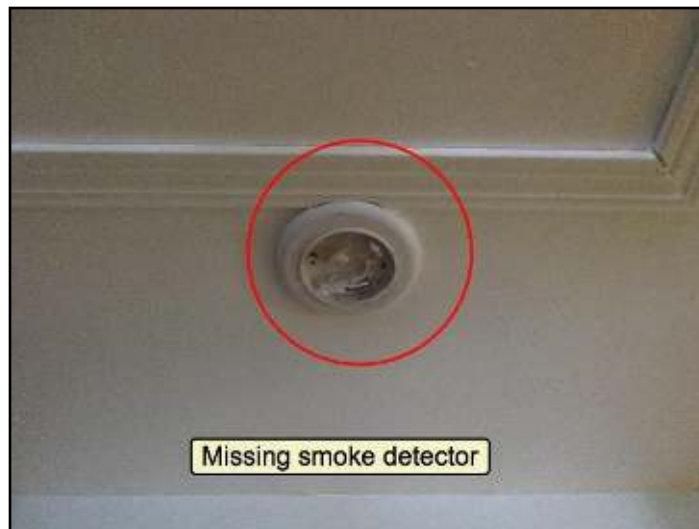
48. Missing

8. Condition: • Missing

Implication(s): Fire hazard

Task: Repair or replace

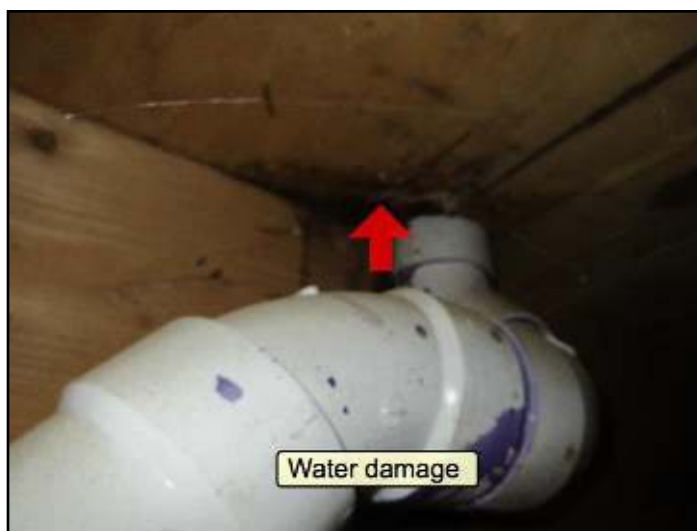
71. Leak

11. Condition: • [Leak](#)

It appears that the toilet in the main bathroom needs to have the Wax ring replaced there is a leak in the crawl space

Task: Repair or replace

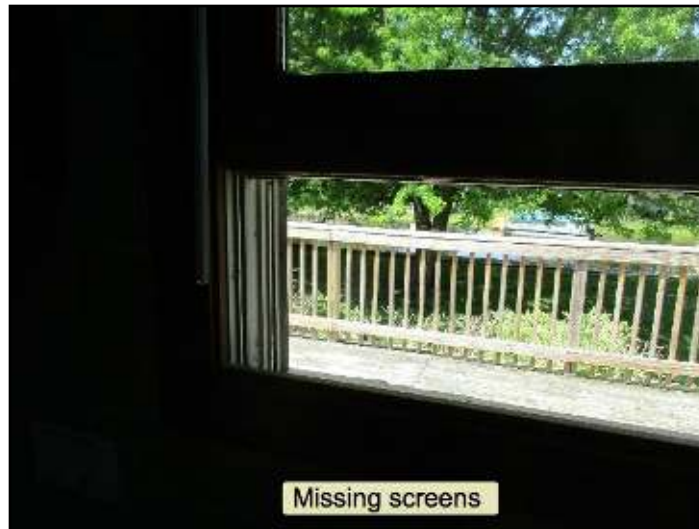
111. Missing

12. Condition: • [Missing](#)

Task: Repair or replace

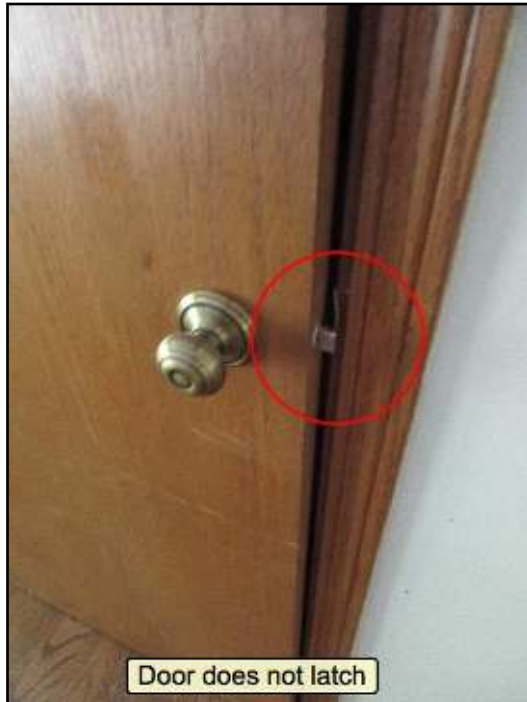
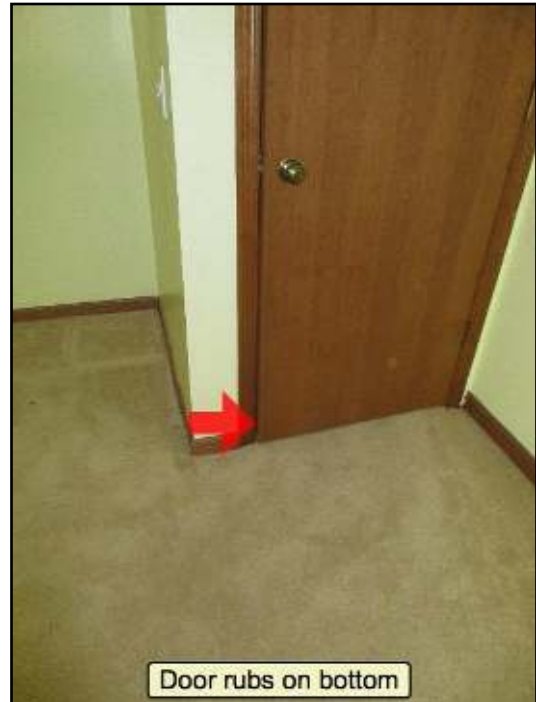
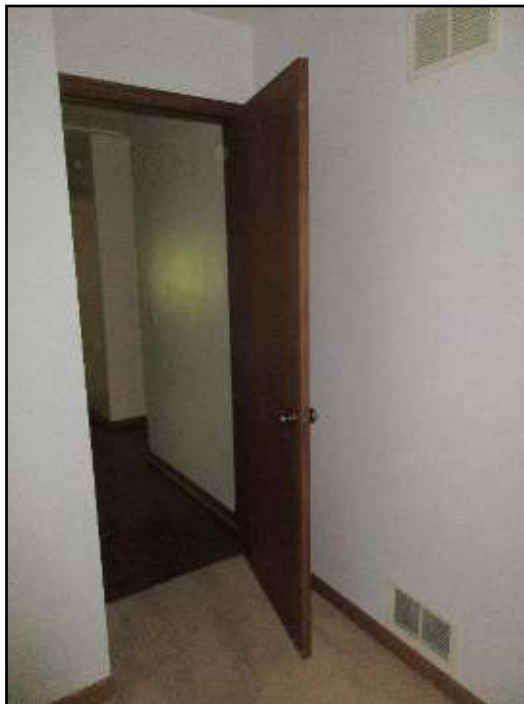
13. Condition: • [Loose or poor fit](#)

Implication(s): Chance of damage to finishes and structure

112. Loose or poor fit

113. Loose or poor fit

114. *Loose or poor fit*
