INSPECTION REPORT

For the Property at:
2700 WISCONSIN AVE
ANYTOWN, IL 00000

Inspection Date: Tuesday, November 22, 2016

RE: Report No. 1246, v.2
2700 Wisconsin ave
Anytown, IL
00000

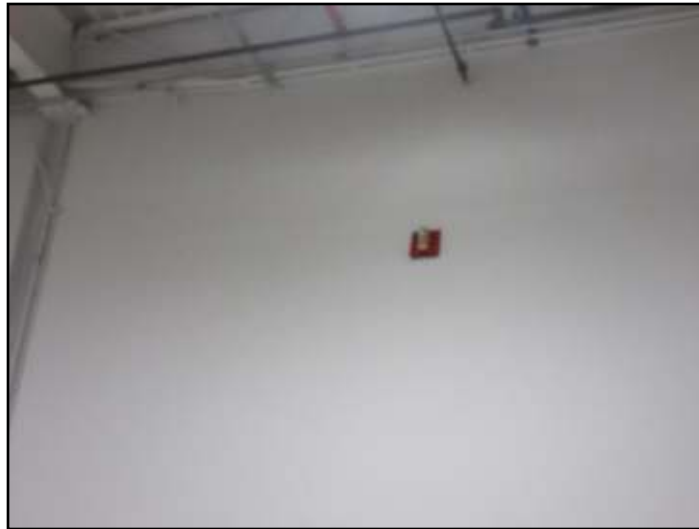
22.

1. • The fire alarm / strobe located in the central warehouse on the west side of the building appears that its has been hit and is not connected to the wall. this should be looked at by a qualified tech to reattach and determine if the unit has been damaged

Task: Repair or replace

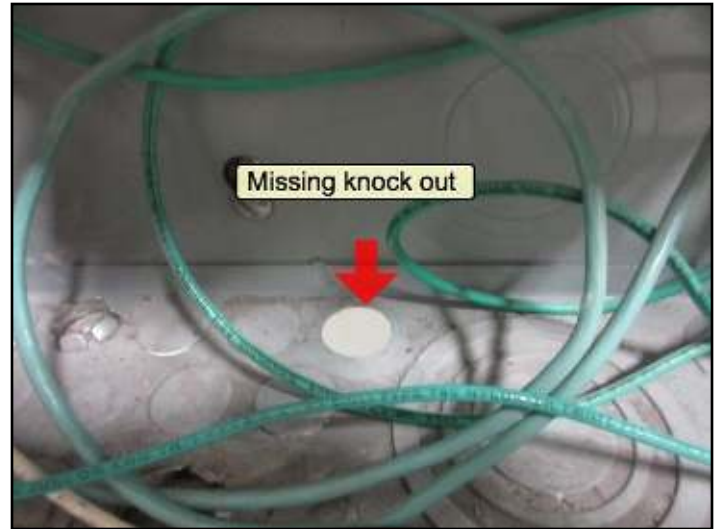
24. Double-tap connection(s)

4. **Condition:** • Double-tap connection(s)

the electrical sub panel on the east side in the middle room has a double tap condition that needs to be addressed and the bottom of the box needs to have a plug inserted to close the knockout

Task: Repair

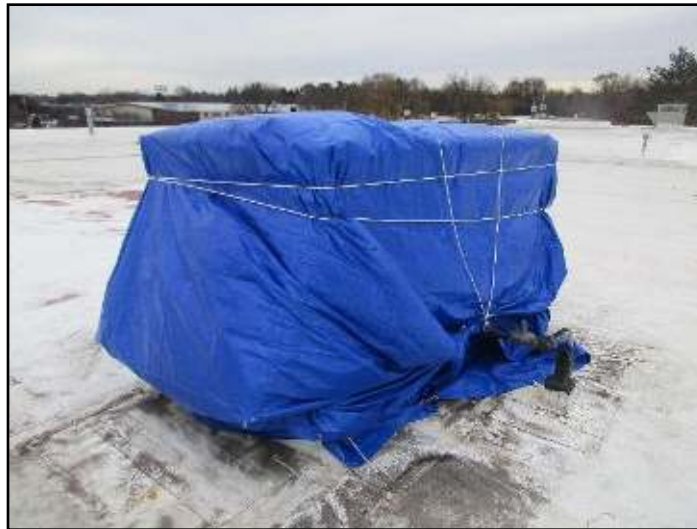
44. Between 16 to 20 years old

RTU#6 was cover by a blue tarp and not running the current owners switched the unit on and it did fire the blue tarp is to determine where a leak is coming from. The manufactures data plate was not visible at time of the inspection. the assumption is that is the same age as rest of the units.

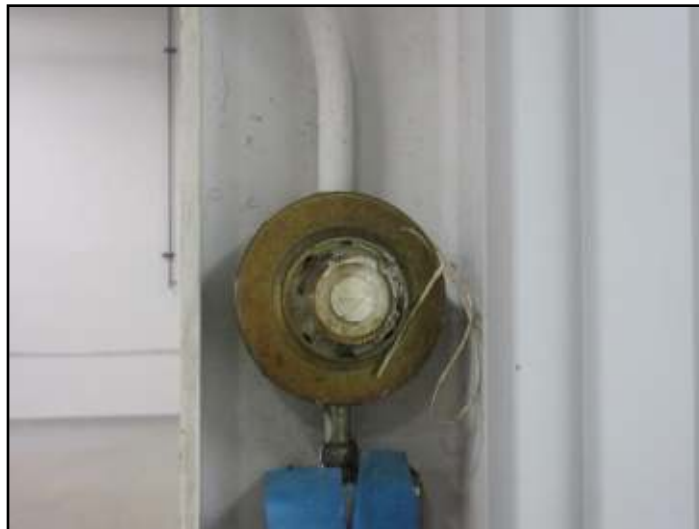
55.

7. • Gas piping located in the room on the east side of the building north of the incoming electrical service has several gas pipes that are not secured to the wall and could become damaged and leak natural gas in the building

Implication(s): broken gas line and potential explosion

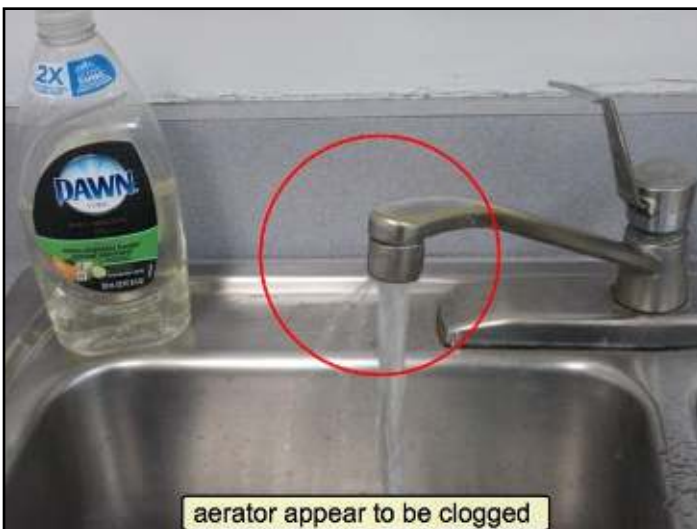
101. Leaking faucet(s)

37. Condition: • Leaking faucet(s)

kitchen in the rear of the warehouse has an aerator that is clogged and should be replaced. the waste lines also are leaking and should be repaired to prevent the cabinet from rotting on the bottom

Task: Repair or replace

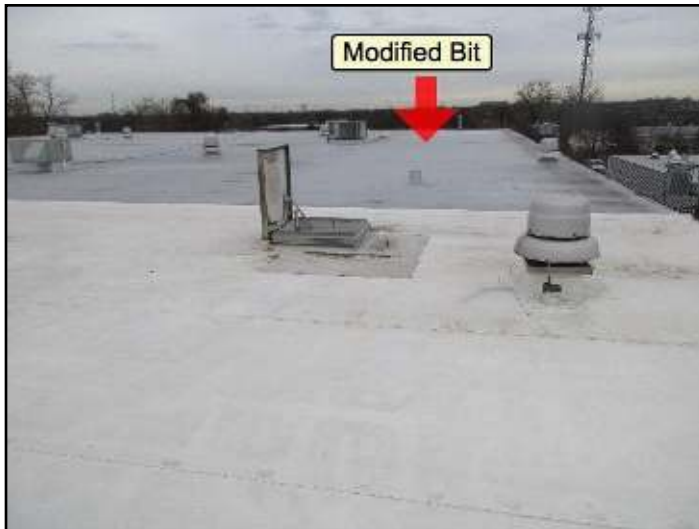
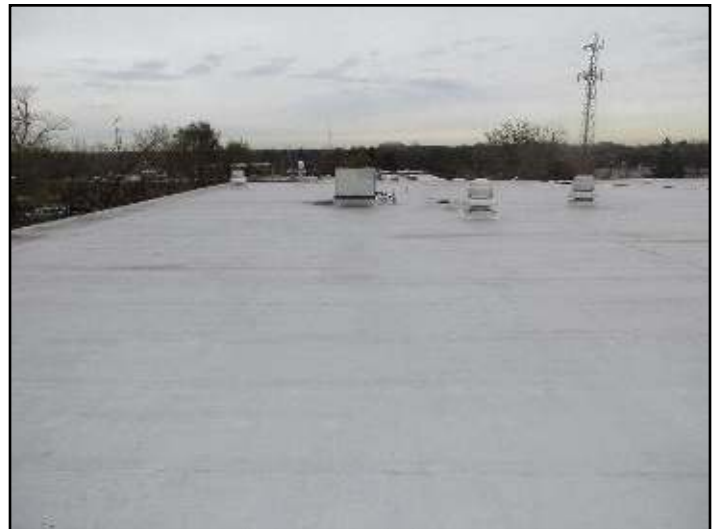
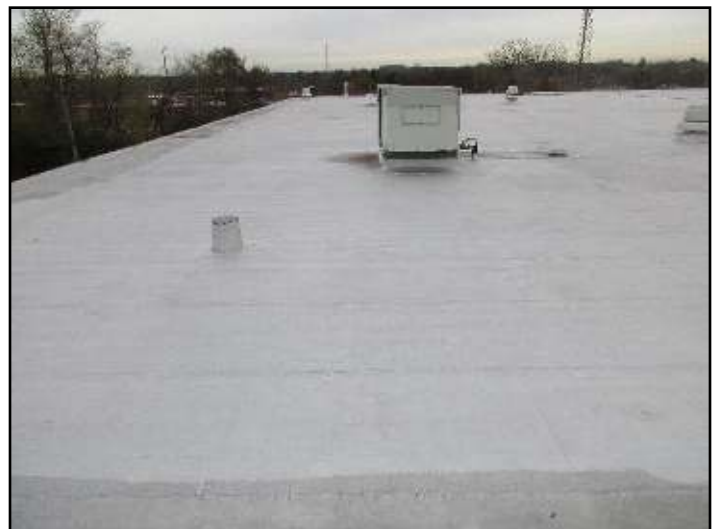
The modified bit roof is in good condition but the owners should start thinking of budgeting money for replacement

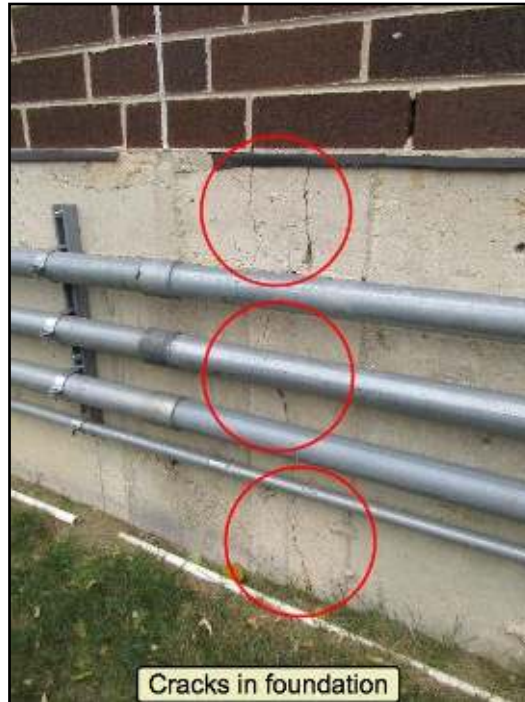
151. Minor cracks were noted

43. Condition: • Minor cracks were noted

Several areas of the foundation on the east side are showing signs of cracking this should be monitored to see if there is any movement in the cracks.

Task: Repair Further evaluation Monitor

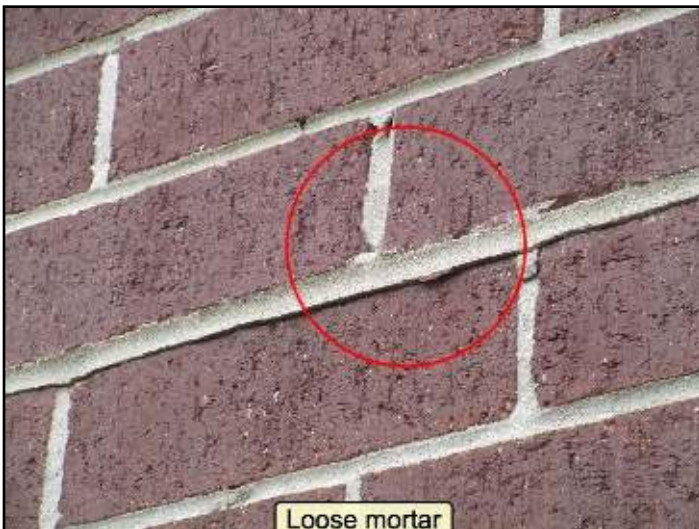
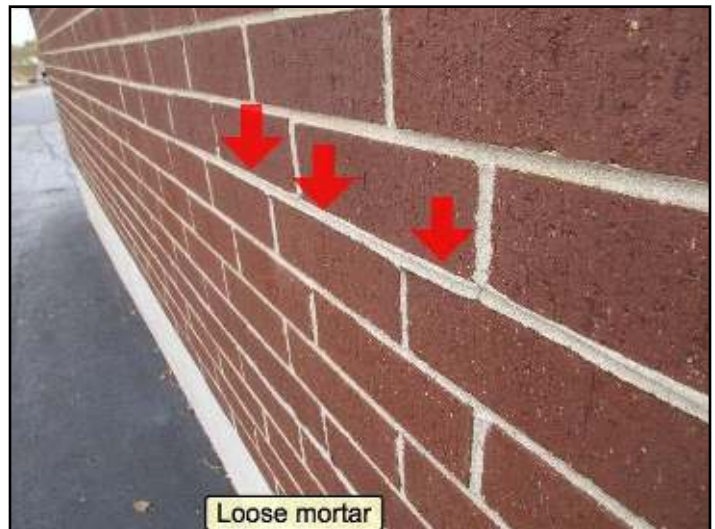
Condition: • Areas of the exterior brick will require some tuck-pointing in the near future the mortar appears to loose on various parts of the building

Implication(s): water infiltration efflorescence and potential brick spauling

Task: Repair Further evaluation Monitor
