INSPECTION REPORT

For the Property at:
2700 WISCONSIN AVE
ANYTOWN, IL 00000

Inspection Date: Tuesday, November 22, 2016

RE: Report No. 1246, v.2
2700 Wisconsin ave
Anytown, IL
00000

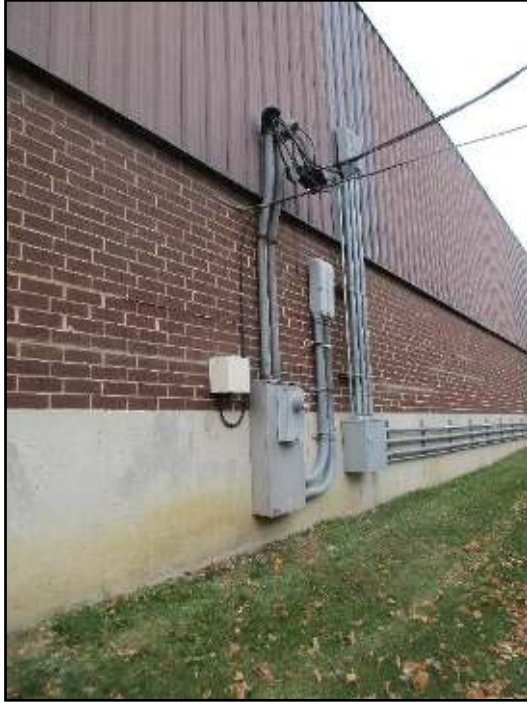
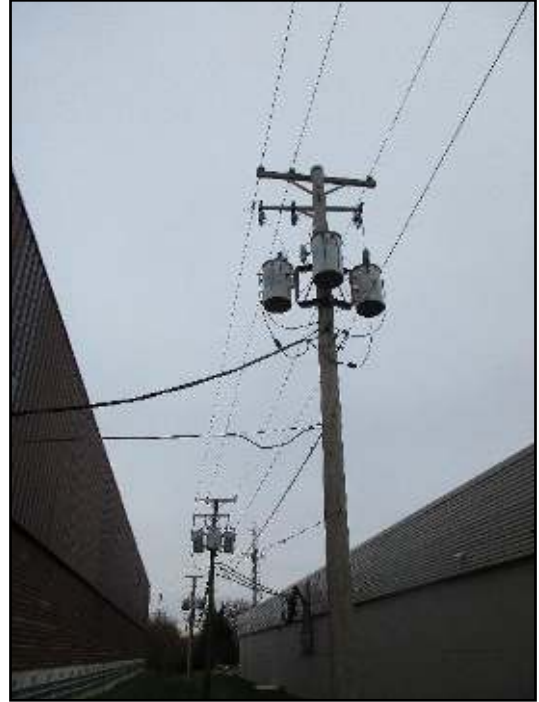
Overhead power lines and pole mounted transformers located on the east side of the building

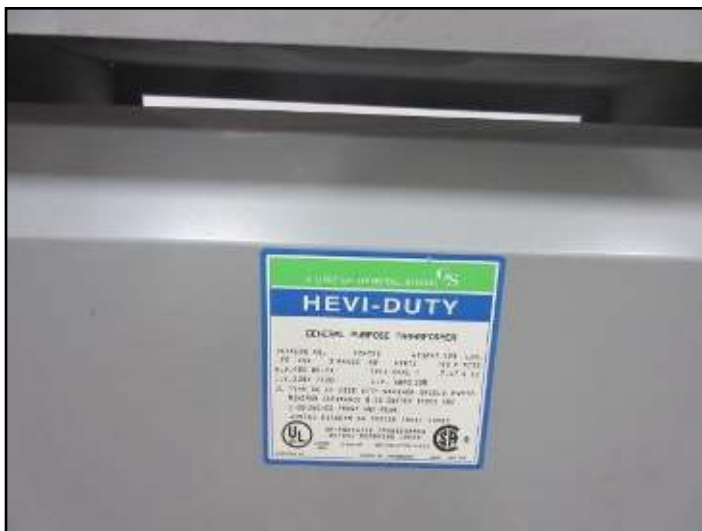
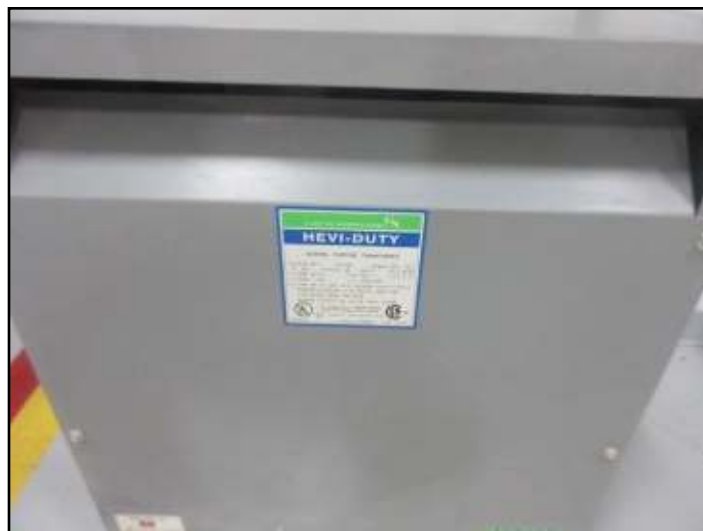
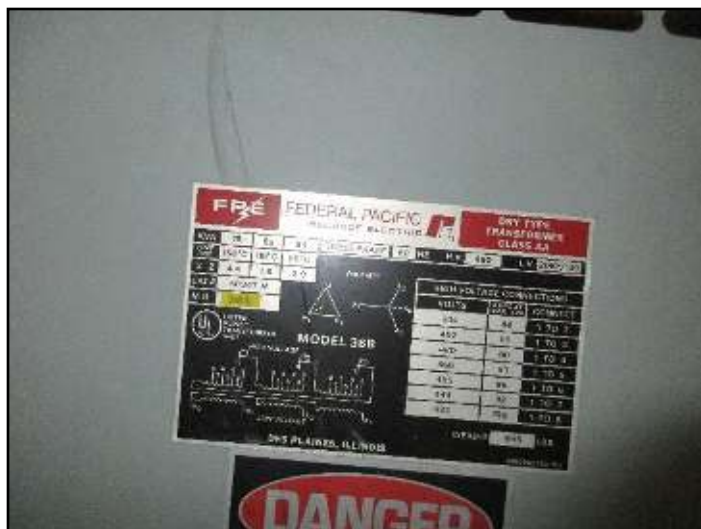
There are three 75KVA transformers located on the building

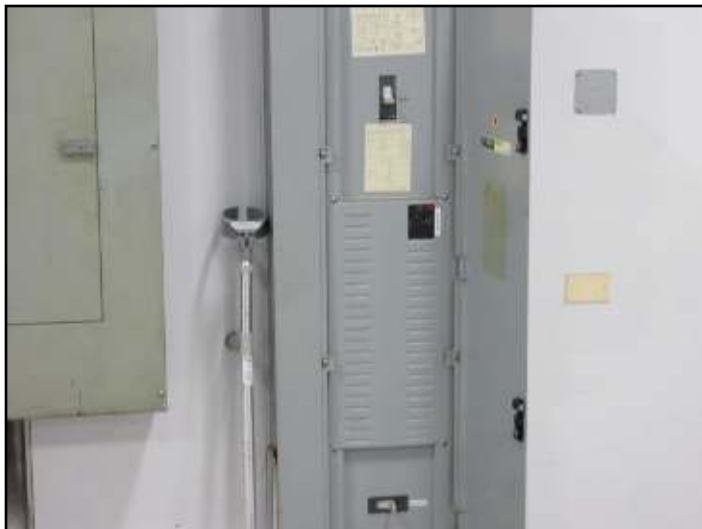
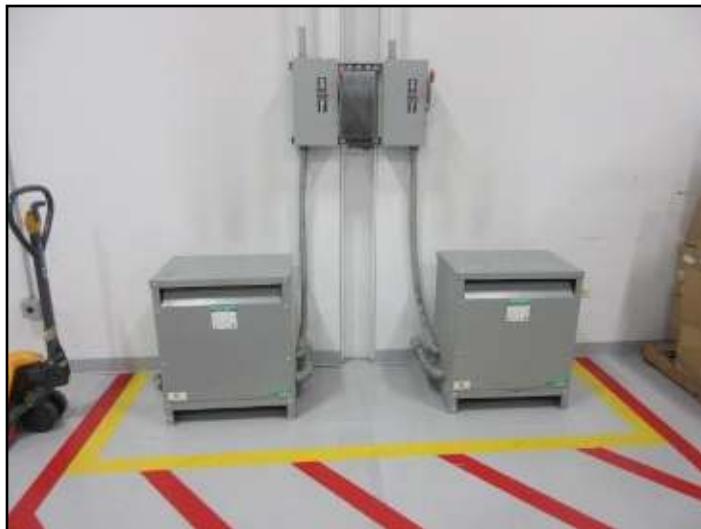
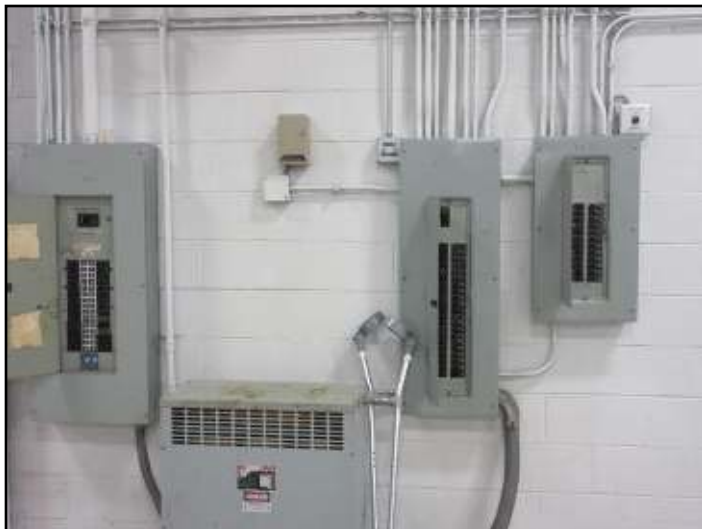
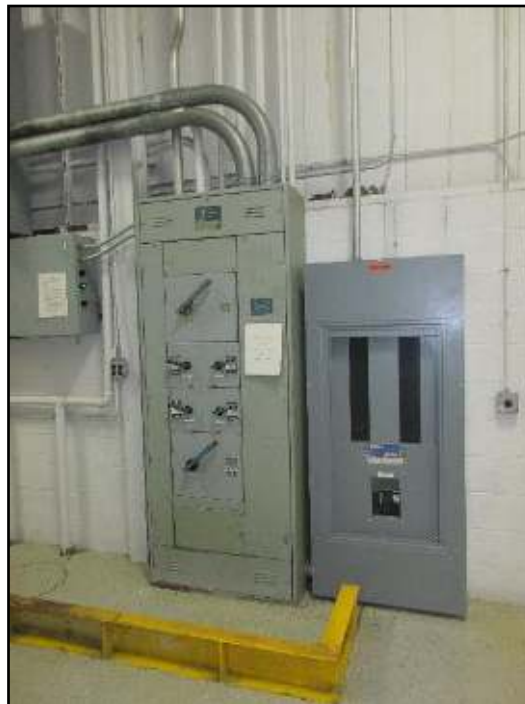
The distribution electrical panels are throughout the building

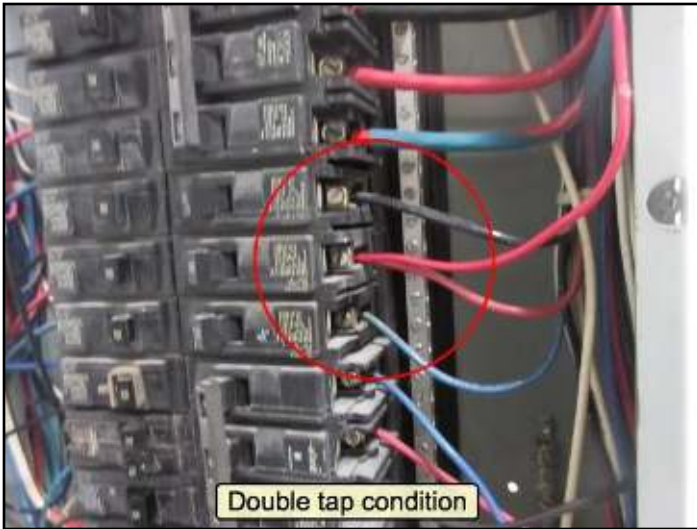
Condition: • Double-tap connection(s)

23. Double-tap connection(s)

Task: Repair

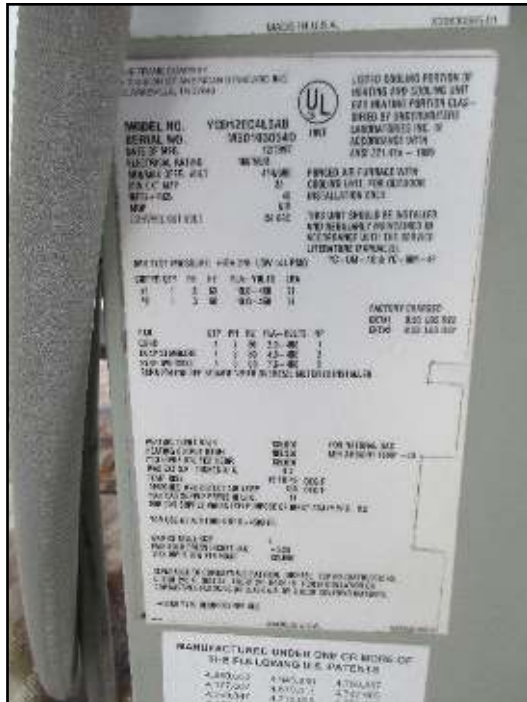
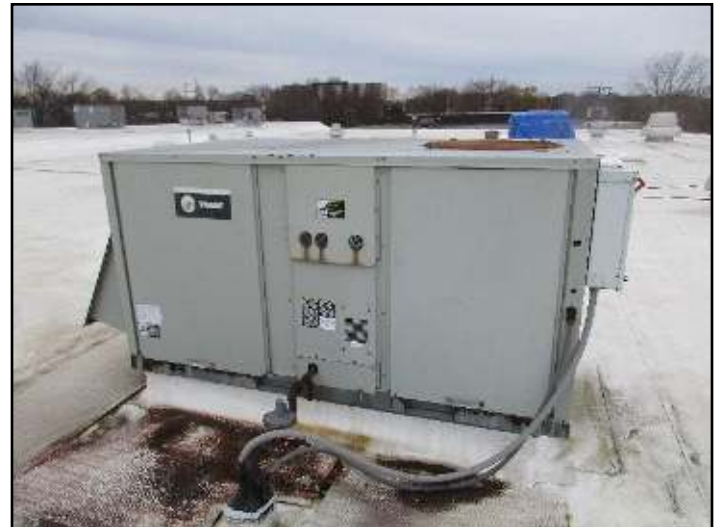
General: • RTU #9 Age and Type is located on the north east edge of the office complex the unit functioned at time of the inspection

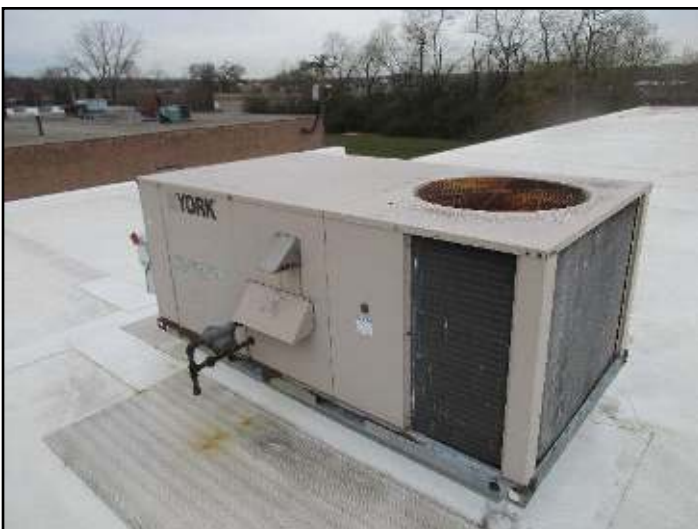
General: • RTU #10 is located on the south side of the office building and functioned at time of the inspection manufacture date 1995

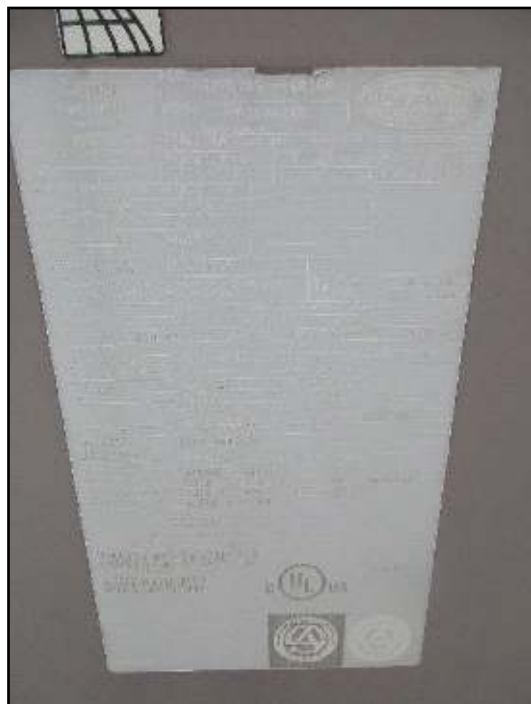
General: • RTU#11 Is located on the south side of the office roof located in the center the unit functioned at time of the inspection

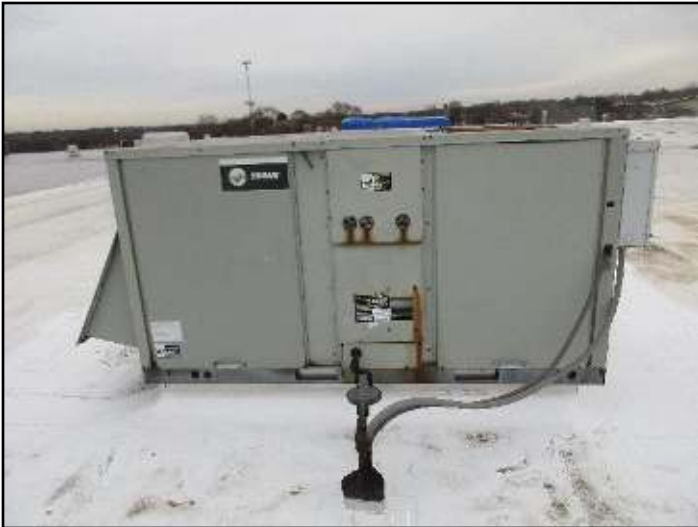
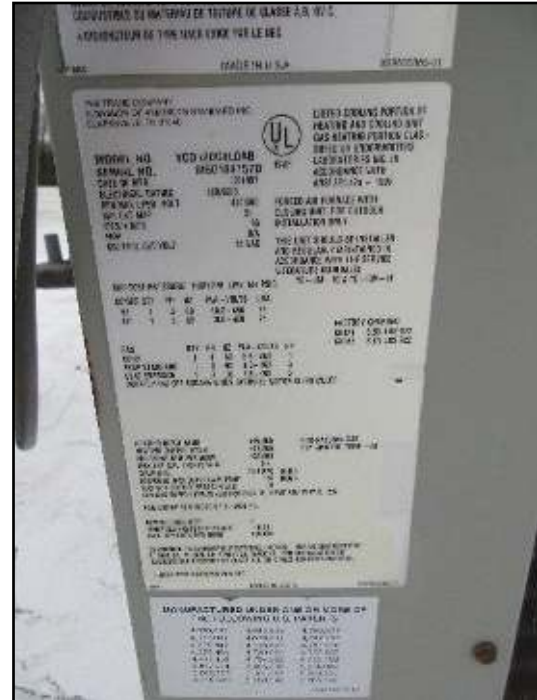
General: • RTU #12 located on the south side of the office east most RTU functioned at time of the inspection
manufacture date 1997

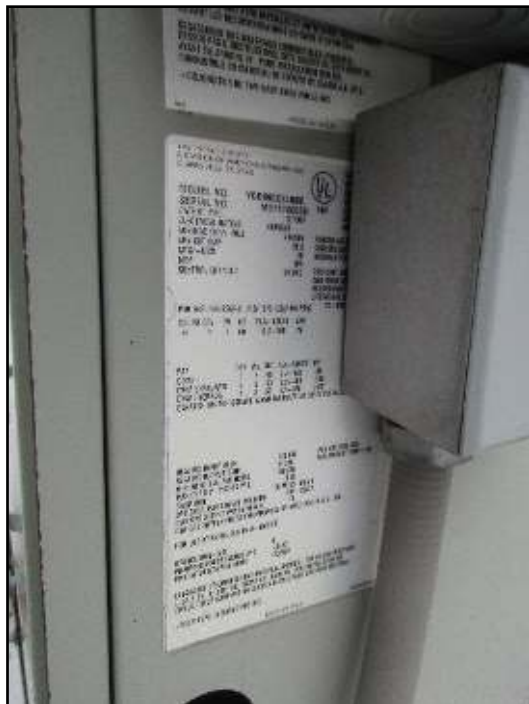
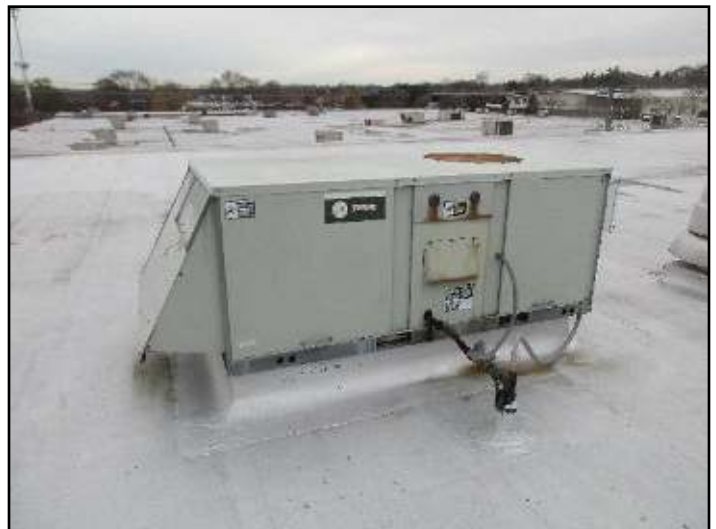
RTU #2 is located on the north end of the roof on the east side the manufacture date is 11/1997 and the unit functioned at time of the inspection

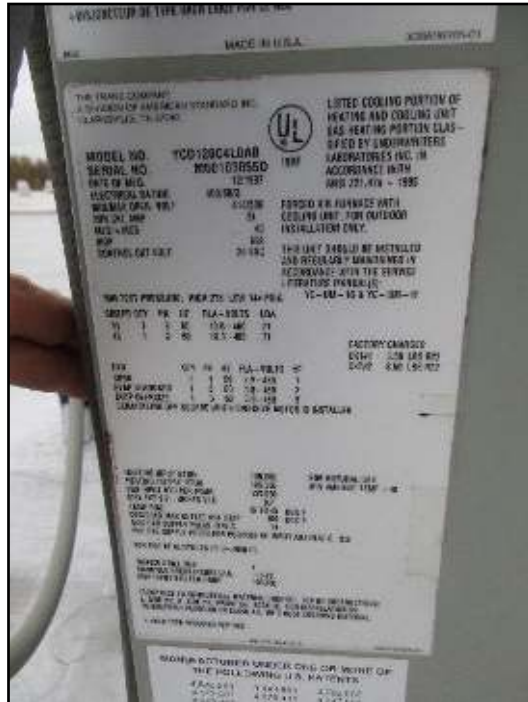
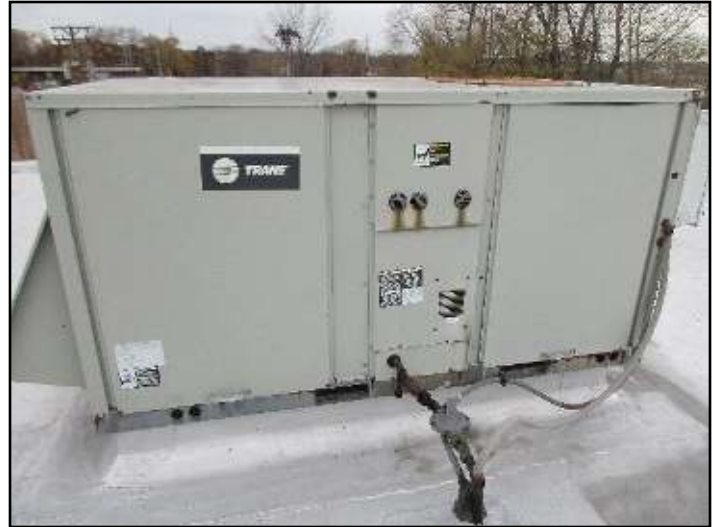
RTU #3 Located on the west side of the roof in the middle of the warehouse functioned at time of the inspection the manufacture date is 12/1997

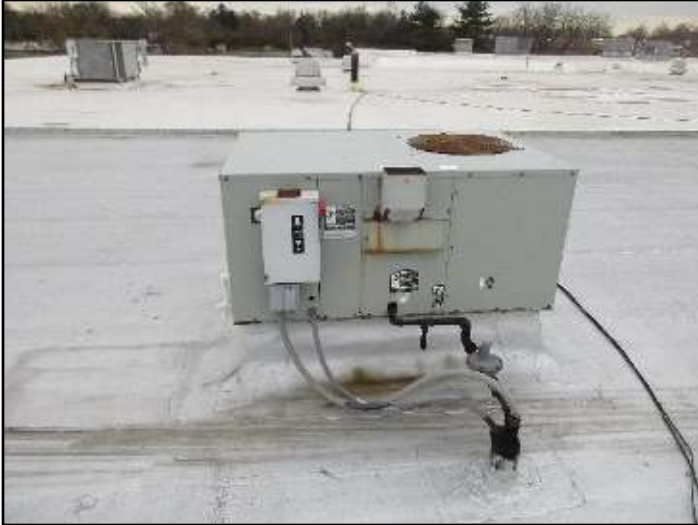
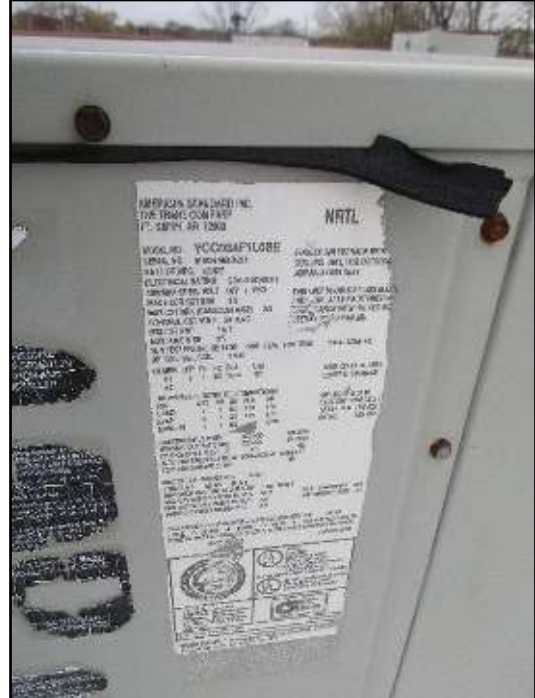
RTU#7 functioned at time of the inspection, location is in the warehouse area farthest south and east on the roof. the manufacture date was 12/1997

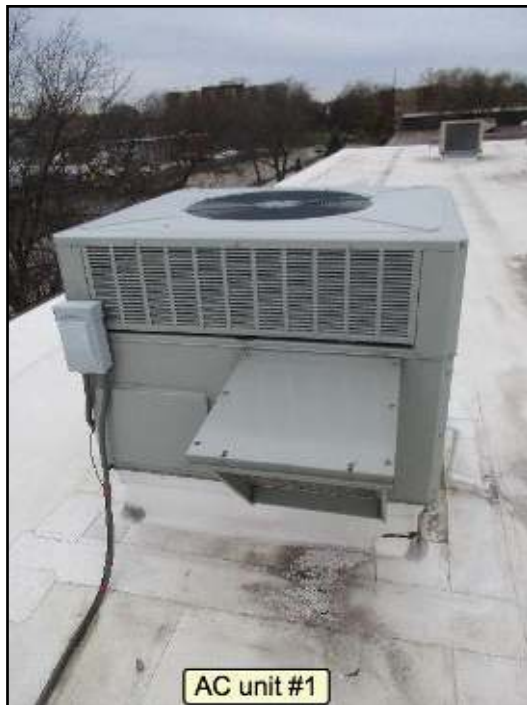
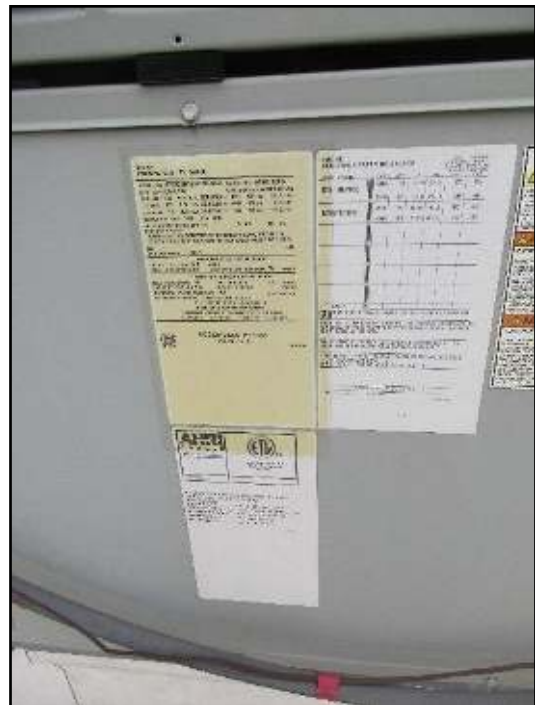
General: • AC unit #1 is located in the office section to cool the second floor computer server room, was not tested at the time of the inspection the temp was 35 degrees

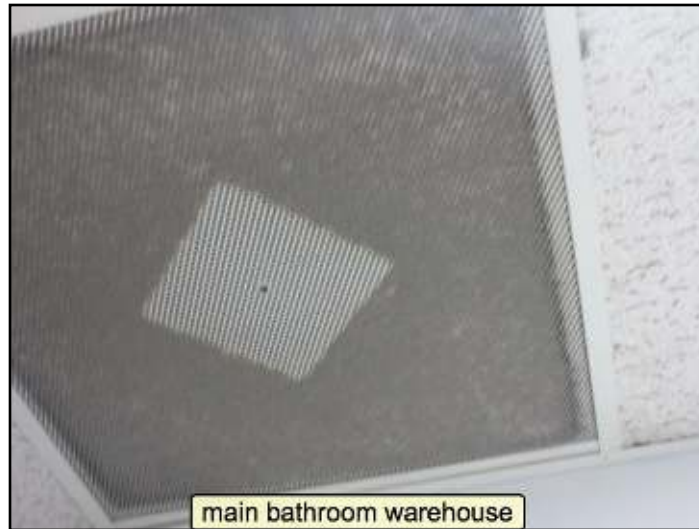
78.

30. Condition: • the exhaust fan intake for the main bathroom in the warehouse needs to be cleaned as it is plugged.

Task: Clean

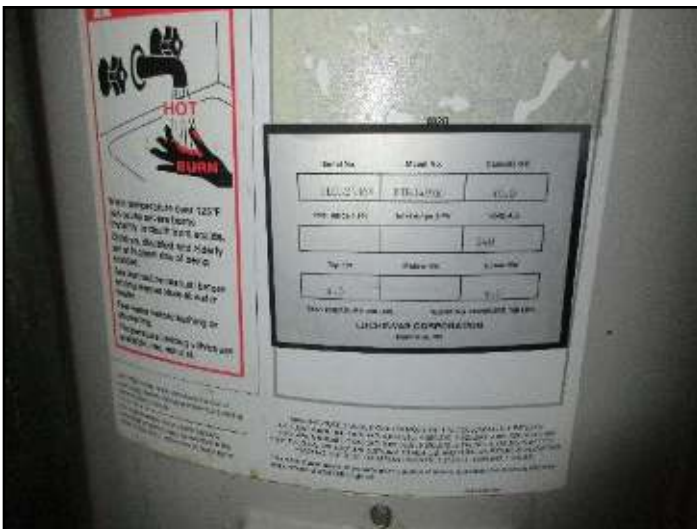
90. Electric

Two electric fired water heaters Lochinvar Water heater functioned at time of the inspection. manufacture date 1997
Model number: ETB040KK Serial number: PLO325369

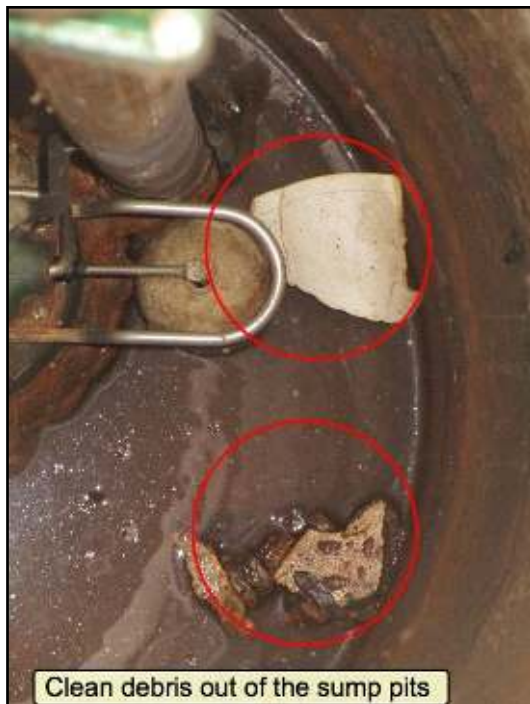
92. Warehouse / loading bay

There is a sump pump in the main warehouse that drains water from the loading dock. The pit is 5' deep and the pit was too small to enter and test the float.

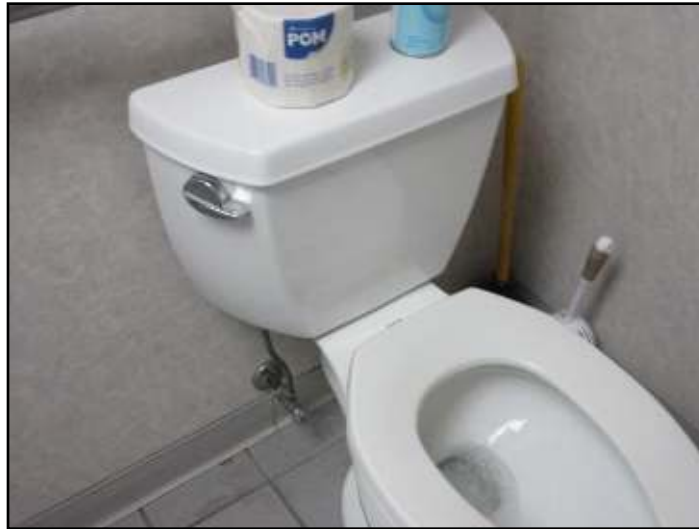
35. Condition: • Did not flush properly

99. *Did not flush properly*

Task: Service Correct

Time: Immediate

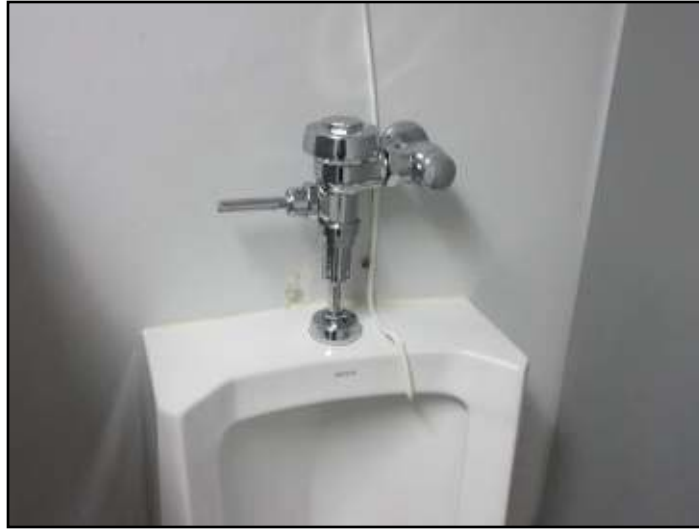
the urinal in the main bathroom in front of the warehouse did not flush properly this is most likely caused by lack of use this needs to be looked at by a plumber

100. Did not flush properly

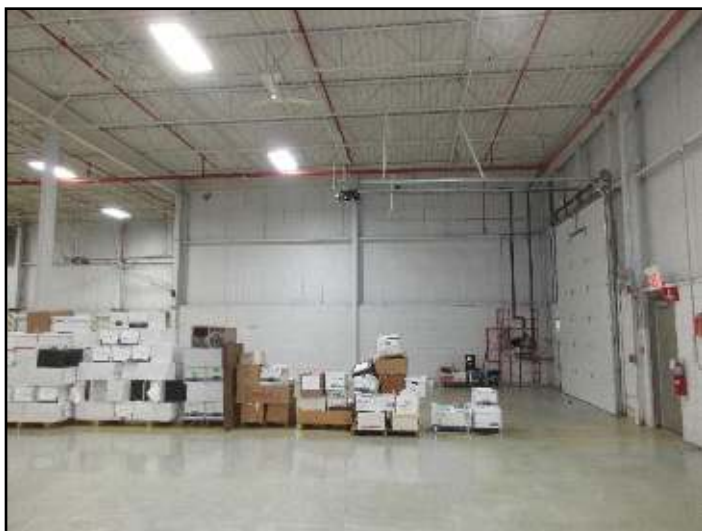
114.

Finished area floor coverings: • Main warehouse floor has been epoxied with a commercial grade epoxy. The east and west side of the building has been completed with a do it yourself epoxy from the big box stores. this product will not last as long as the commercial grade product

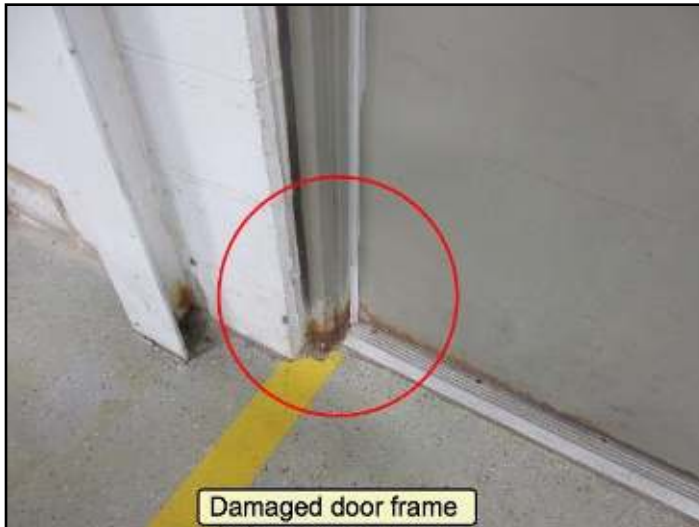
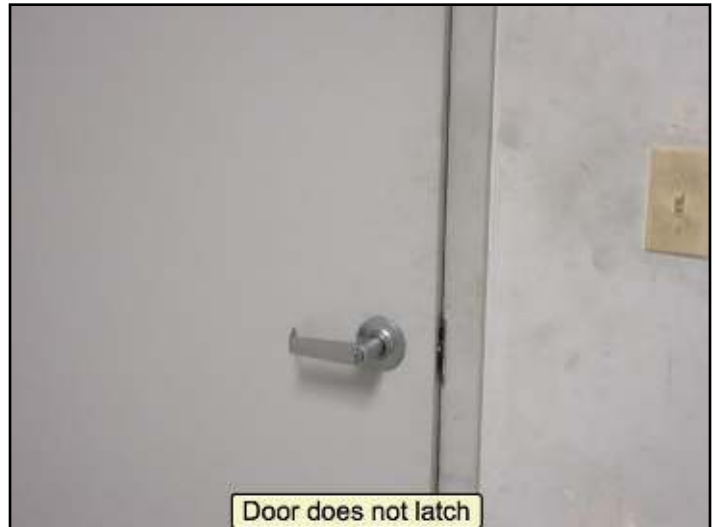
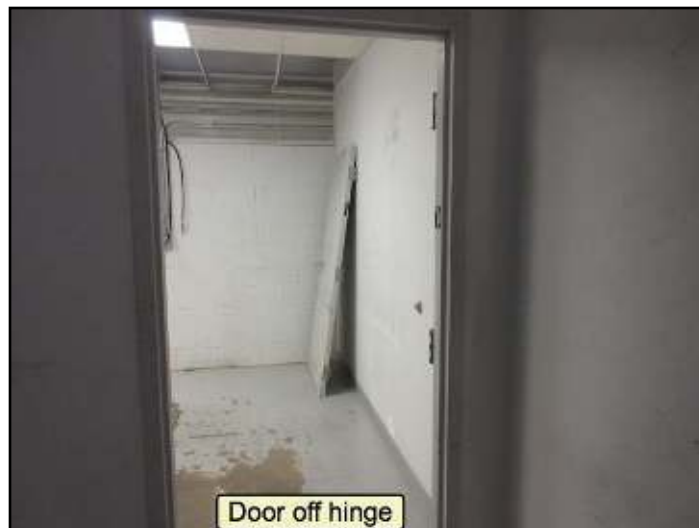
39. Condition: • Walls relatively plumb, doorjambs square and floors reasonably level

Location: Throughout First Floor Second Floor

Task: Further evaluation

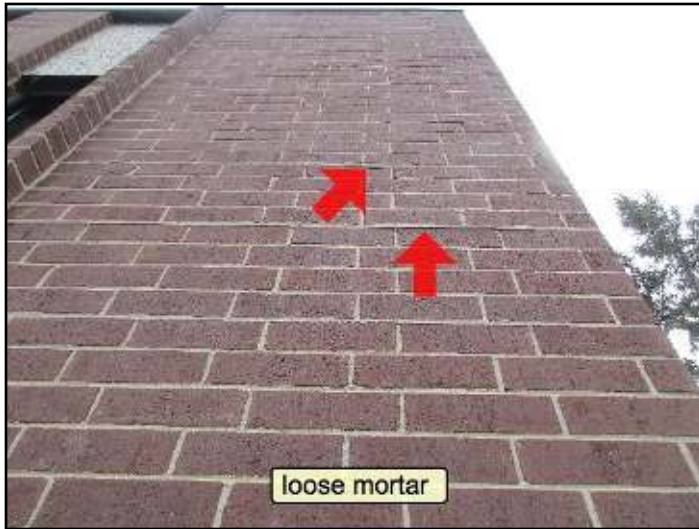
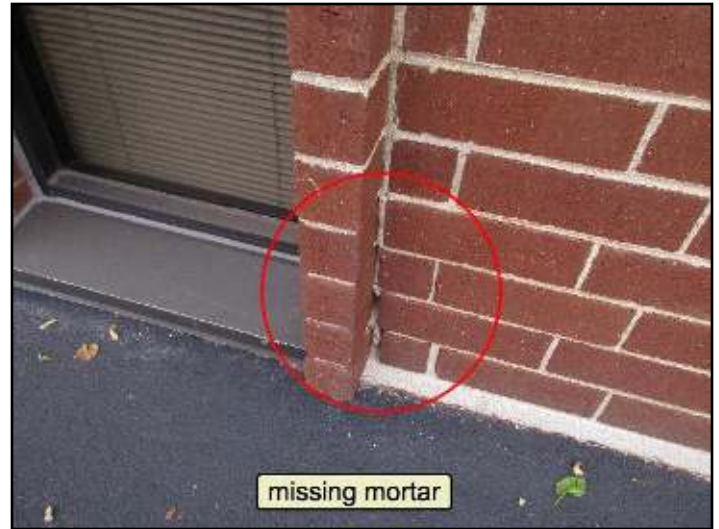
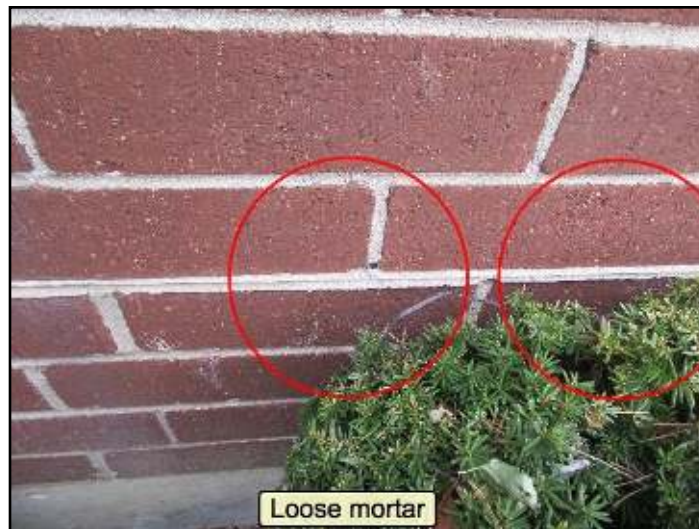
44. Condition: • Areas of the exterior brick will require some tuck-pointing in the near future the mortar appears to loose on various parts of the building

Implication(s): water infiltration efflorescence and potential brick spauling

Task: Repair Further evaluation Monitor

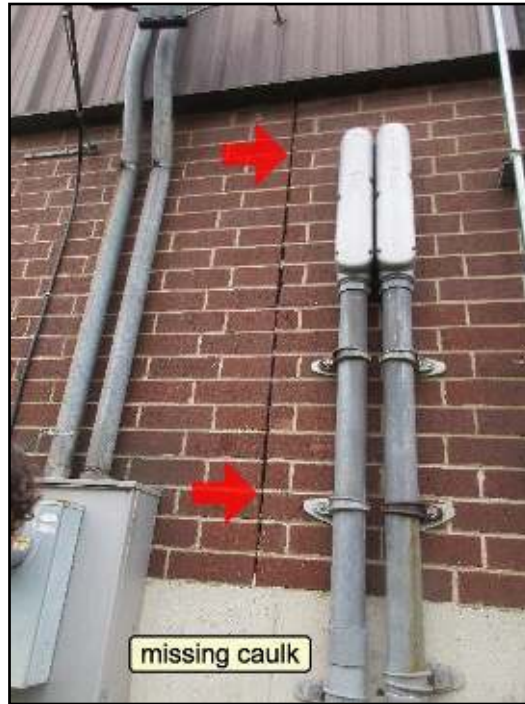
157.

45. Condition: • Caulk expansion joints

Implication(s): water infiltration efflorescence and potential brick spauling

Task: Repair Improve Correct

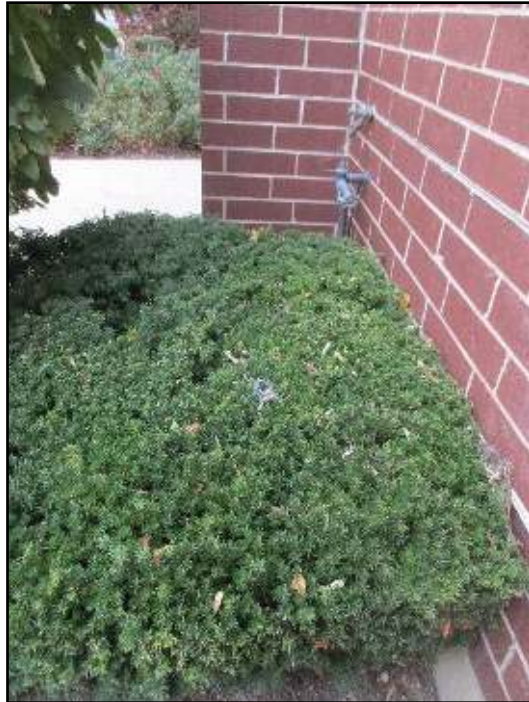
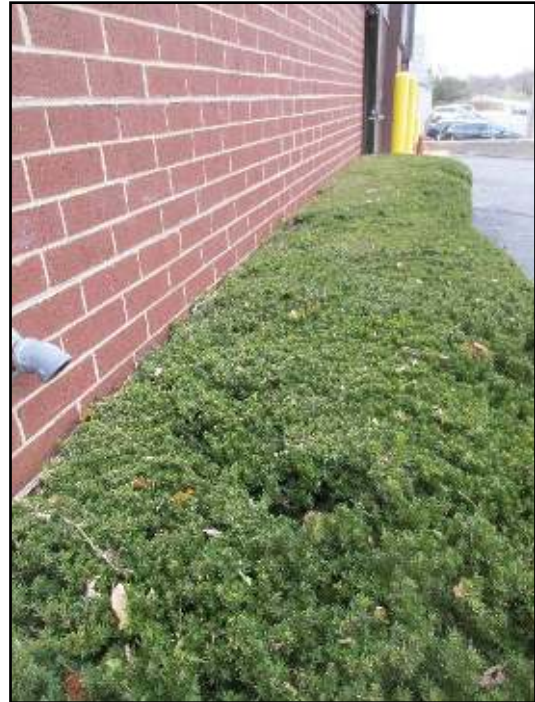
General: • All foliage needs to be cut back from the building to allow the brick to dry after a rain

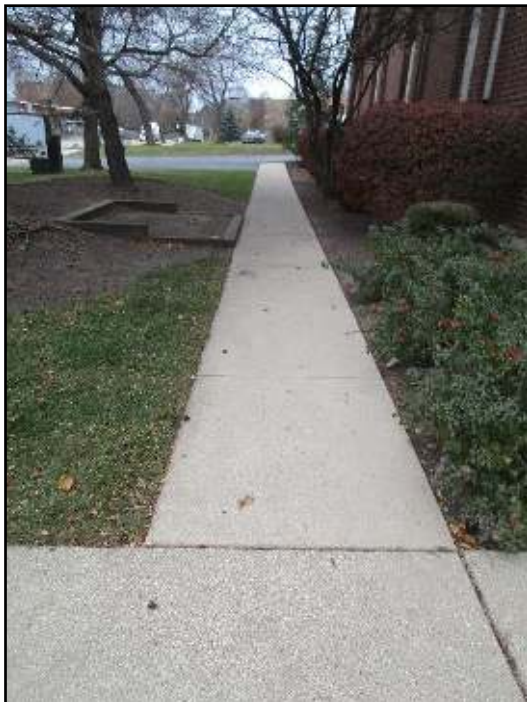
173. Poured-concrete

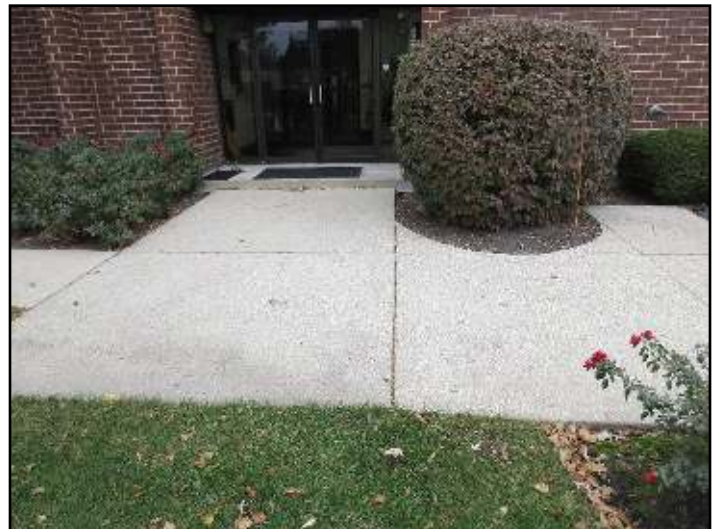
174. Poured-concrete

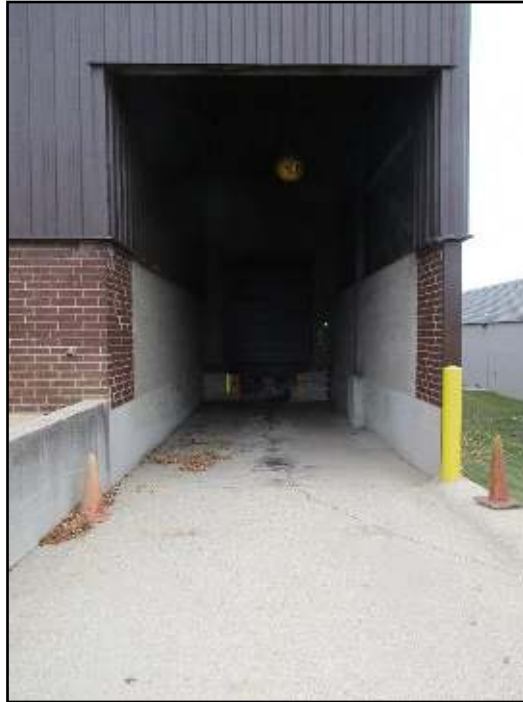
175. Poured-concrete
