INSPECTION REPORT

For the Property at:
612 SPRING ROAD
ANY TOWN, IL 00000

Prepared for: SAMPLE RESIDENTIAL
Inspection Date: Thursday, May 19, 2016
Prepared by: Bob Casey

RE: Report No. 1181, v.2
612 Spring road
Any Town, IL
00000

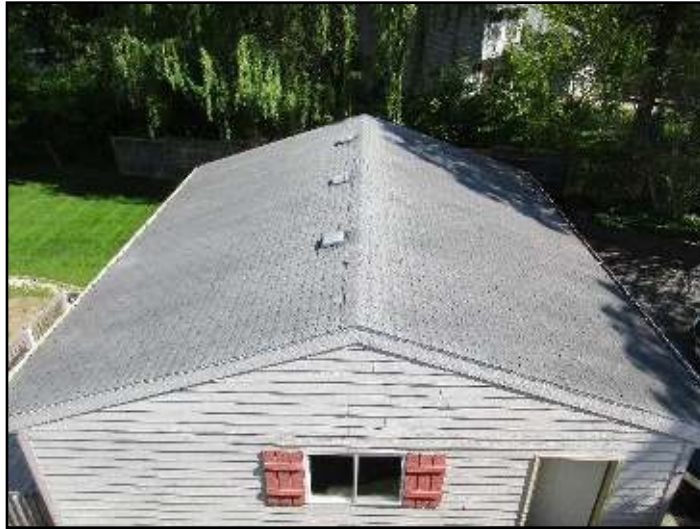
1. Asphalt shingles

Garage roof is a three Tab shingle

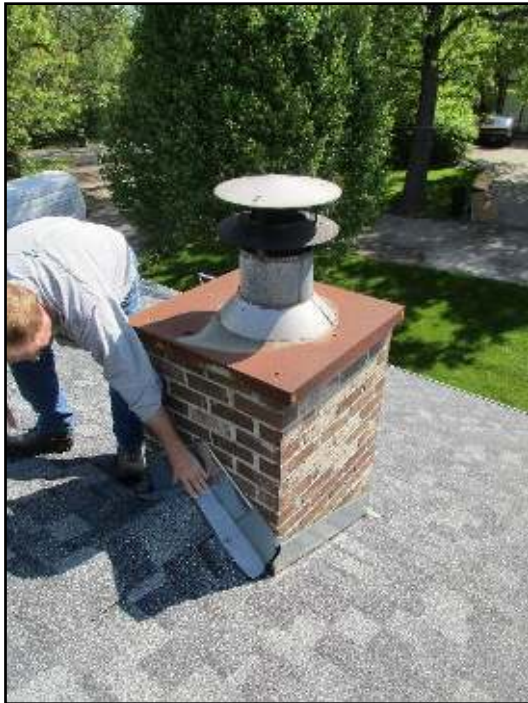
2. Composition shingles

Home has architectural shingle and the roof is in good shape appears to have been replaced recently

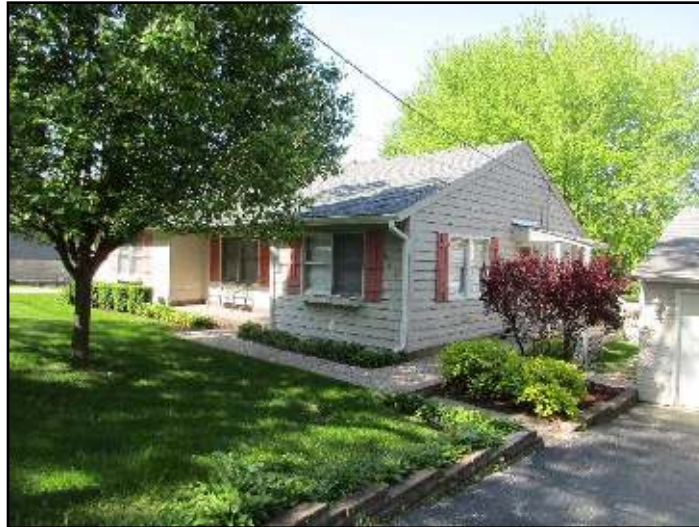
8. Aluminum

Gutters Appear to be securely fasten to the home no evidence of gutters pulling away for the home

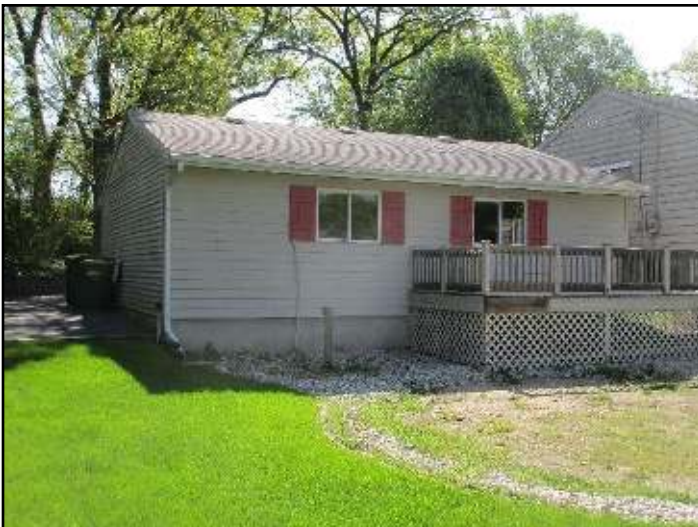
9. Hardboard, plywood or OSB

The siding is a various materials, wood siding, hardie board and vinyl siding depending on which portion of the home / garage you are looking at.

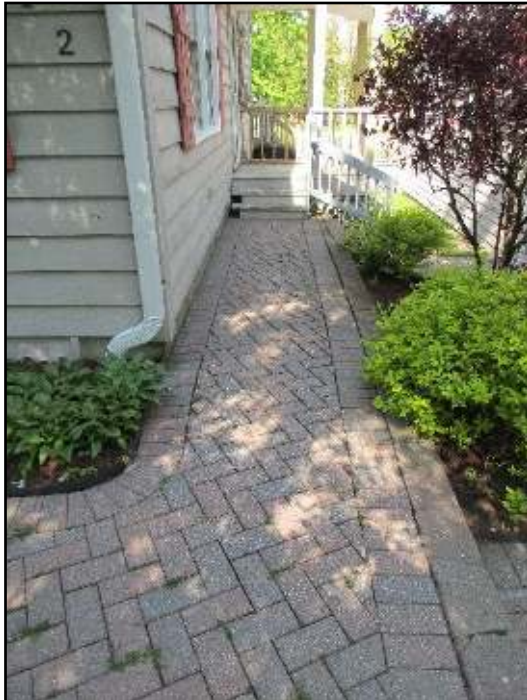
14. Pavers

There is some settling noticed on the walkway but typical for the age of the unit

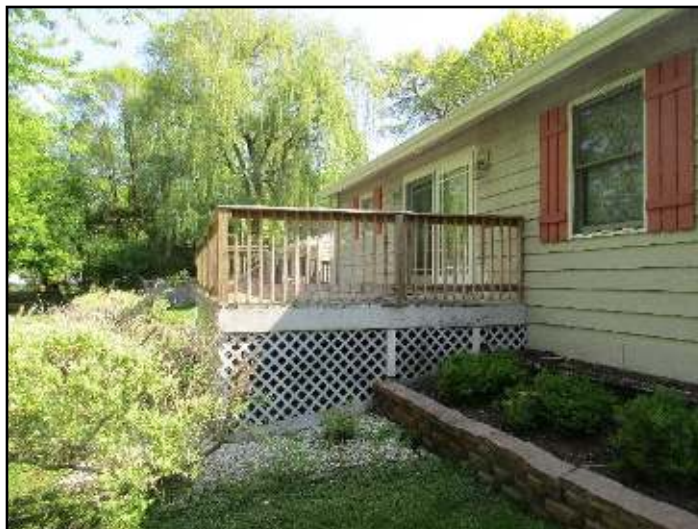
17. Raised

Deck was not accessible underneath

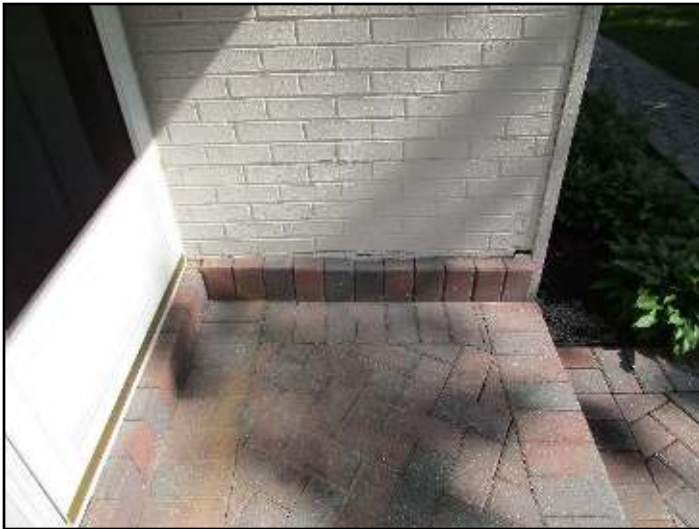
19. Brick

Appears to be in good condition

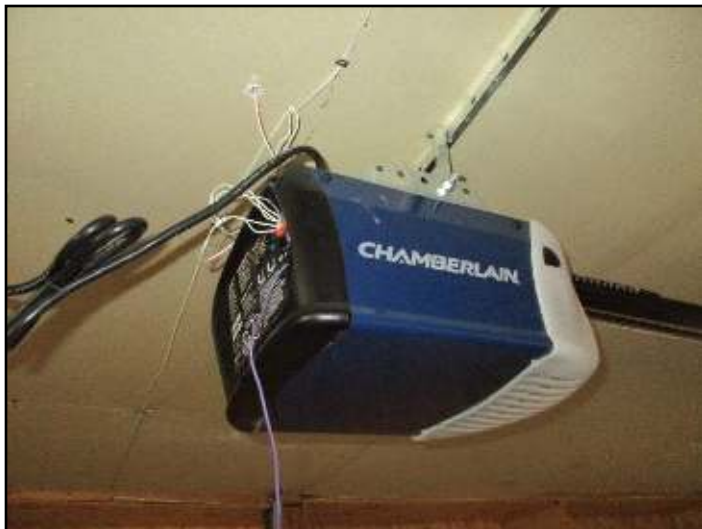
22. General

Detached garage the car doors function with the safety devices

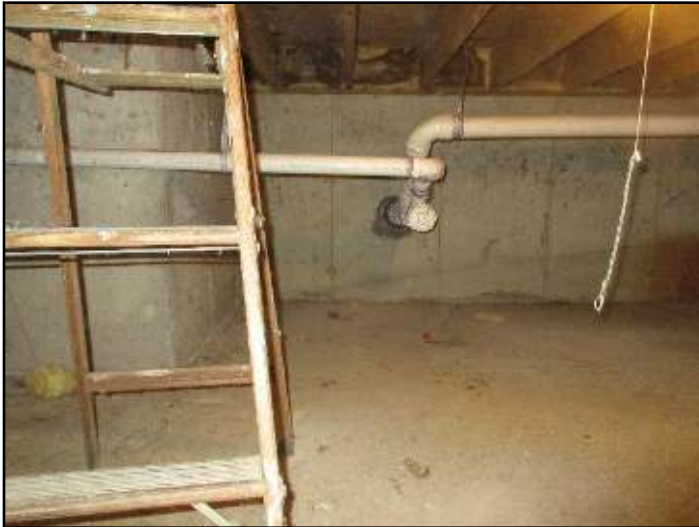
31. Crawl space

Crawl space has a slurry coat on the floor and was dry during the inspection

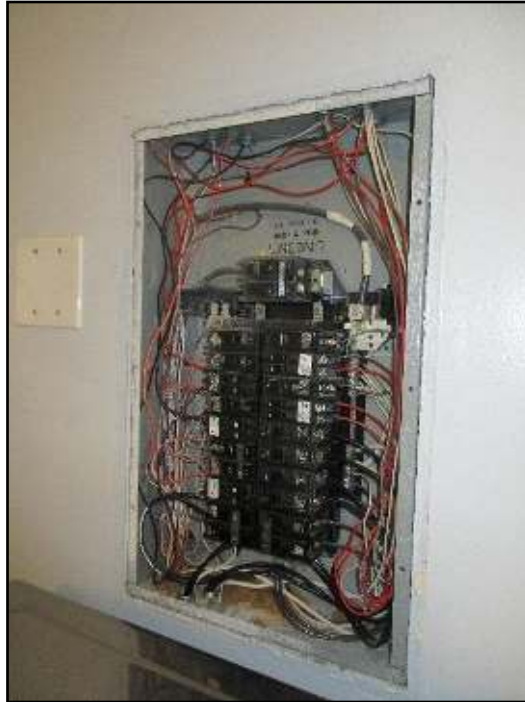
43. 20

Existing panel is full
